MARYLAND CENTER FOR ENVIRONMENTAL TRAINING
19th Annual Maryland Ground Water Symposium
Baltimore, Md

YOUR WELL FIELD Do You Really Know What You Have?

Case Study – SJWD Inman Mills Well Field

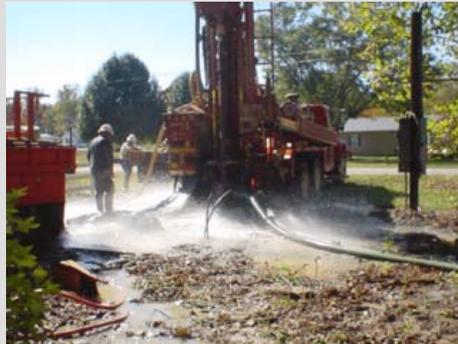
Making improvements to an existing well on the Piedmont

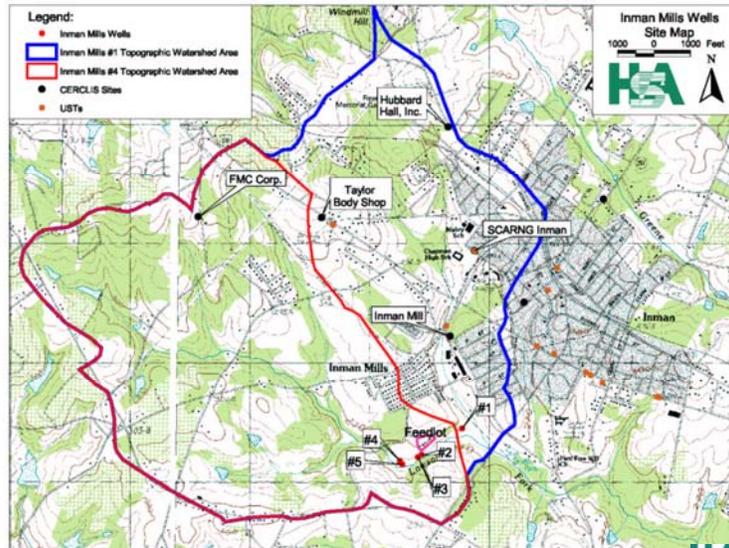
Inman Mills – Hydrogeological Assessment

- Hydrogeological Assessment
- Downhole Camera Surveys of Wells #1 and #4
- Review of Existing Well Data
- Qualitative Assessment of Sustainable Yield of Wells
- Recommendations on Further Development of Wellfield/Aquifer

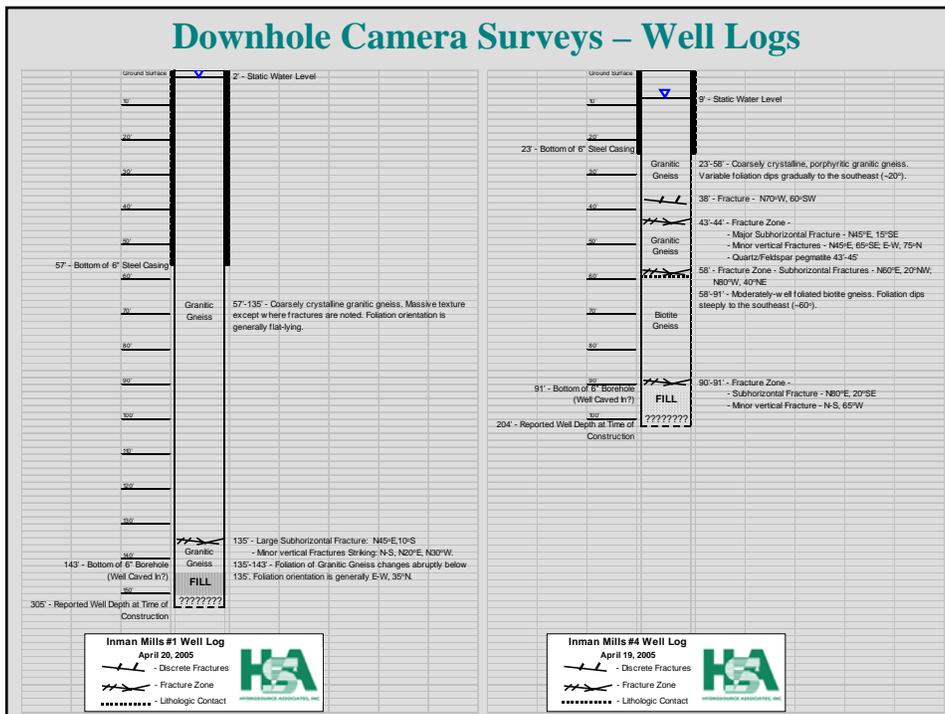
Downhole Camera Surveys – Well Logs

- Documentation of construction specifics, assesses the physical condition of the wells, and provides qualitative estimates of potential well yields.
- The video investigations into Wells #1 and #4 revealed that both wells were filled in with sediment to the base of the pump.
- Camera investigations also revealed that the existing steel well casing used in these wells had deteriorated over the years.
- Several bedrock structures of a variety of orientations were found to intersect both wells. The majority of the structures observed in Inman Mills Wells #1 and #4 have a nearly horizontal orientation.

- The overall density of fracturing within the wells indicated that additional fractures would likely be intersected should the wells be cleared of debris and/or deepened past their current depths.
- Through discussions between HSA the water district, the district chose to construct new wells within the Inman Mills well field rather than rehabilitate the existing wells.
- The construction of new wells allowed for the replacement of deteriorating well casing and also allowed for larger casing diameter required to realize the full yield potential of the aquifer.

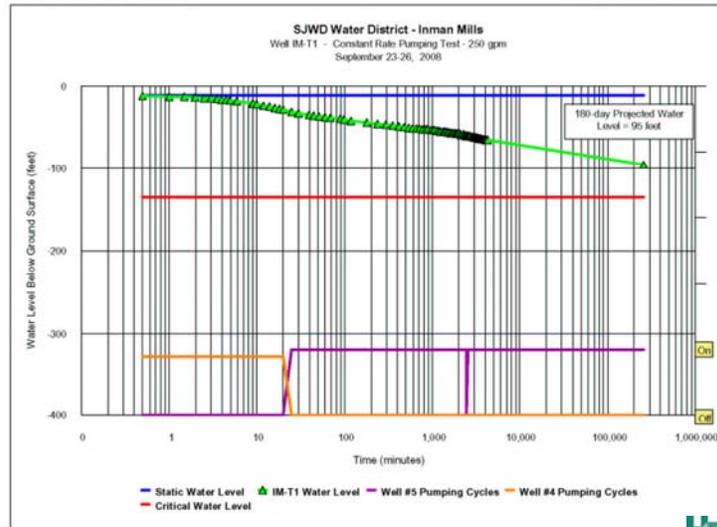
Well IM-T1 – 72-Hour Constant Rate Pumping Test

- Well IM-T1 has a long term sustainable yield of 250 gpm (360,000 gpd)
- Well IM-T2 has a long term sustainable yield of 150 gpm (216,000 gpd)
- This represents a total sustainable yield of approximately 576,000 gpd from only two wells
- Pumping interference between the two wells is negligible
- All water quality parameters were found to be within state and EPA standards with similar water chemistry to the existing wells.

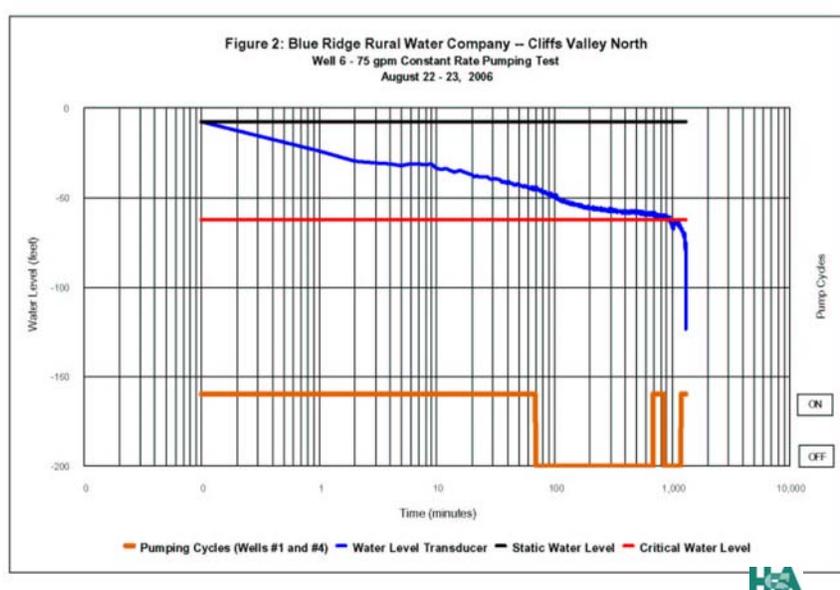
Well #6 – Constant Rate Pumping Test

- Well reportedly yields 100 gpm or more
- HSA client to receive well from developer under contracted agreement based on yield
- Client wishes to validate the reported yield of the well.

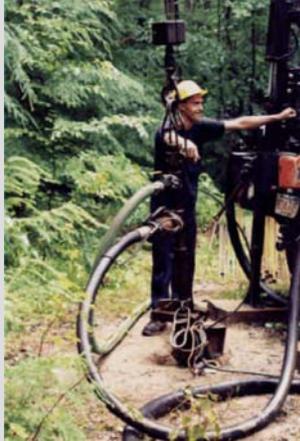
Hydrofracturing a well.

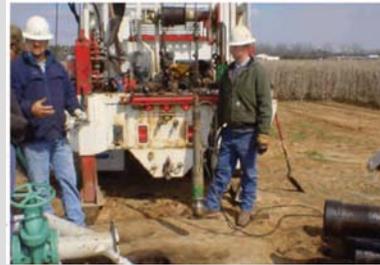
Preparing to lower the Airburst acoustic wave generator gun.
